I. MINI-MISER PUSHBUTTON MEMBRANE REPLACEMENT

The pushbutton membrane on the networks console may fail in time due to normal wear/tear. The following photos will assist in the replacement of a membrane.

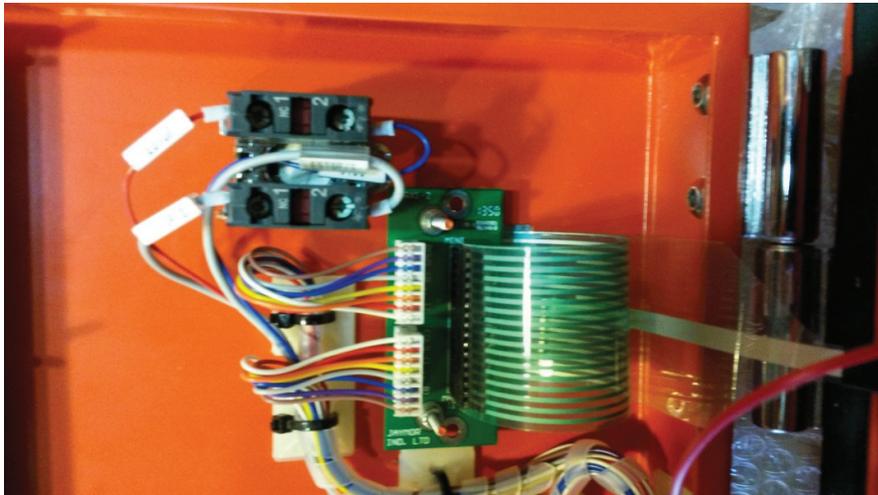
1. Turn off power to the networks console, then disconnect the emergency stop button, shield wire and ribbon connector from inside the operator console taking note of where the ribbon was plugged in.

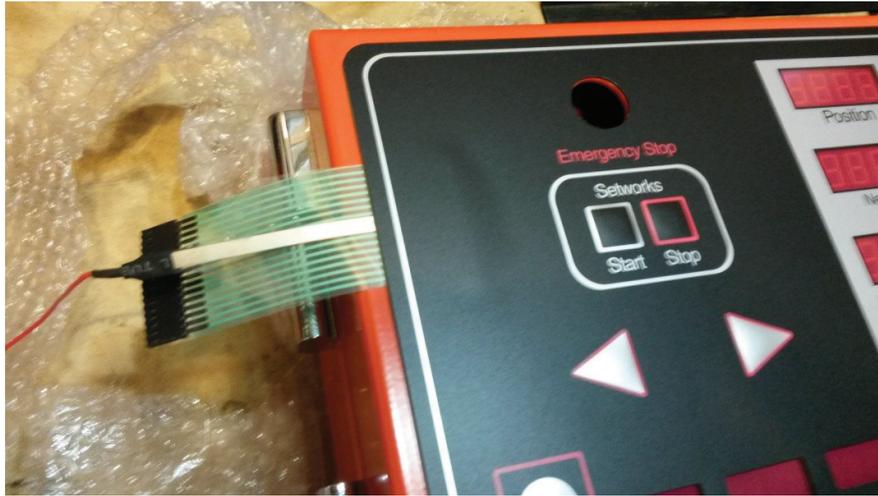
2. Remove the existing membrane and clean the networks console with suitable cleaner like windex and grease remover and allow to dry completely.

- Place the new membrane on the operator console, with the ribbon not yet inserted into the operator console.

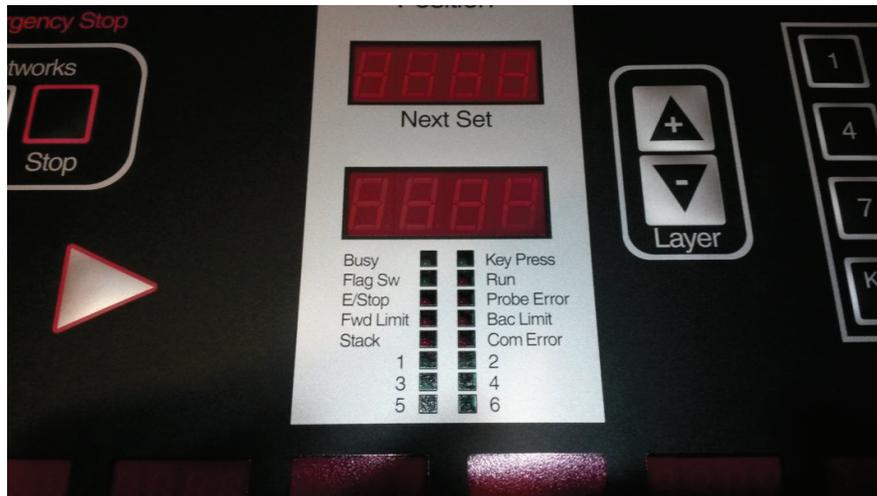
- Position the membrane so all displays are viewable through the red transparent windows, the hole for the emergency stop button is correctly aligned and the status LED's are viewable through the 5mm square clear windows.

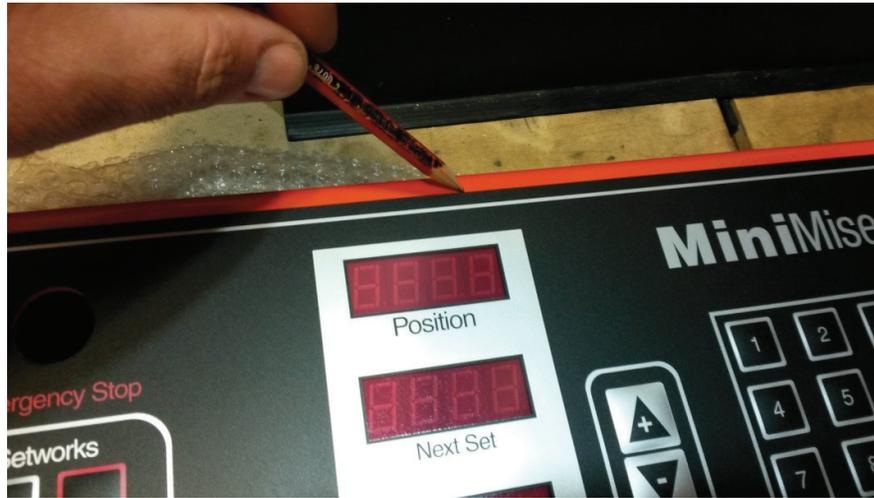
5. Mark the outline of the membrane on the networks console.

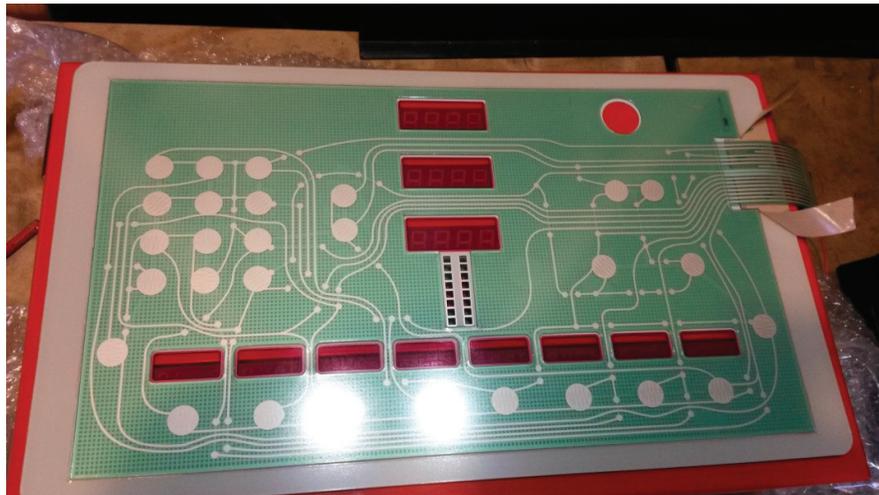
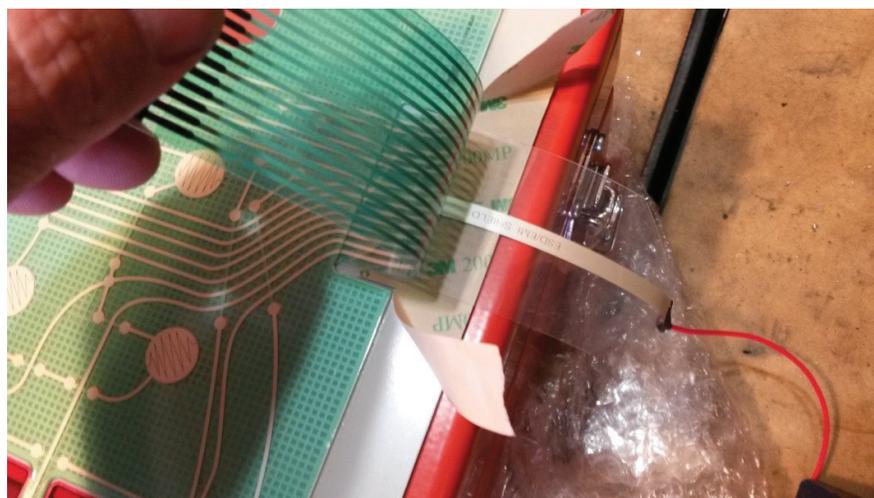
6. Remove the membrane, turn over and remove the protective layer from the self adhesive side of the membrane, leaving a small portion under the ribbon so that it does not stick to the membrane.

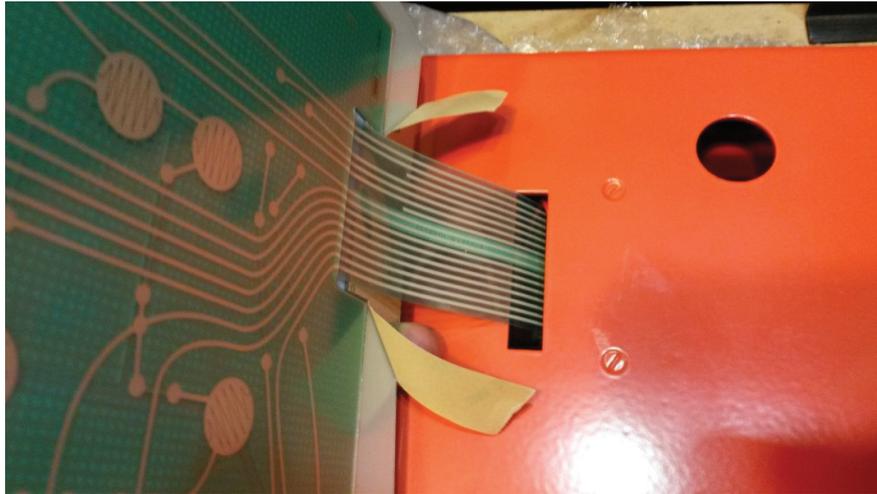
7. Begin placing the membrane on the console by carefully inserting the shield wire and ribbon into the slot in the networks console.

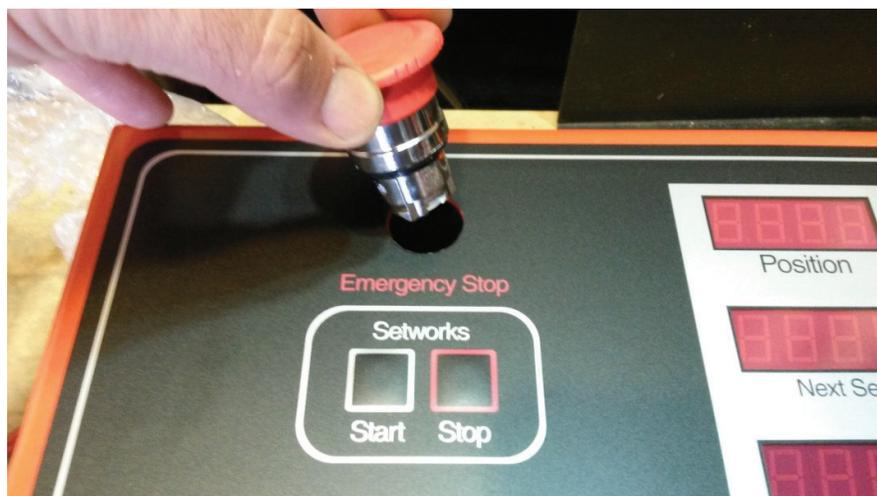
8. Once the ribbon and shield wire are through the slot position the membrane over the console aligned with the outside marking made previously. Attempt to lay the membrane on the console from the opposite side of the ribbon first, then before the ribbon side is laid on the console, remove the last piece of the protective backing from under the ribbon.

Take care at all times not to fold/crease the ribbon,

9. Once the membrane is on the console, go over the surface area around the pushbuttons and display windows making sure the entire surface has been pressed onto the console to adhere.
10. Replace the emergency stop button.

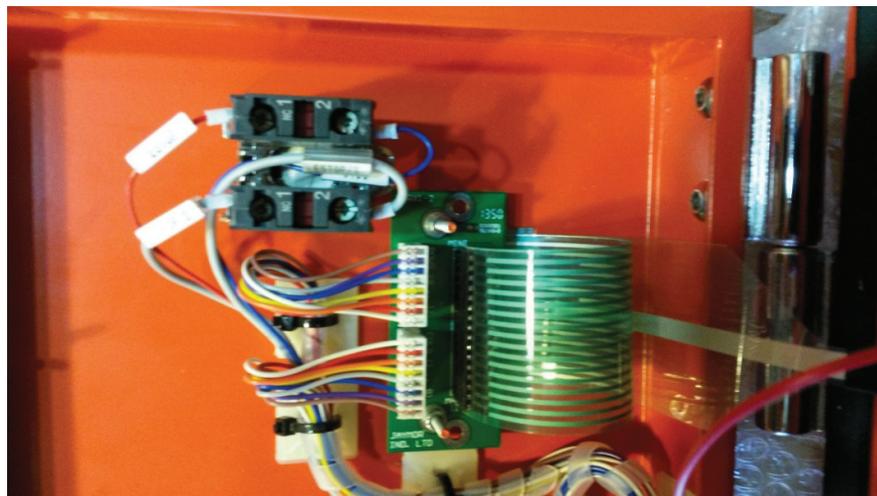
11. Re-attach the ribbon and shield wire (crimp terminal required).
The ribbon has 2 possible connections, and the circuit board will be labelled showing the mini-miser connection.

12. Re-power the networks console and check all pushbutton operations.
